REPORT ON
OIL AND HAZARDOUS MATERIALS SITE EVALUATION
PIERS 1, 2 & 3
NORTHERN AVENUE
BOSTON, MASSACHUSETTS

File No. 5556

December 1984

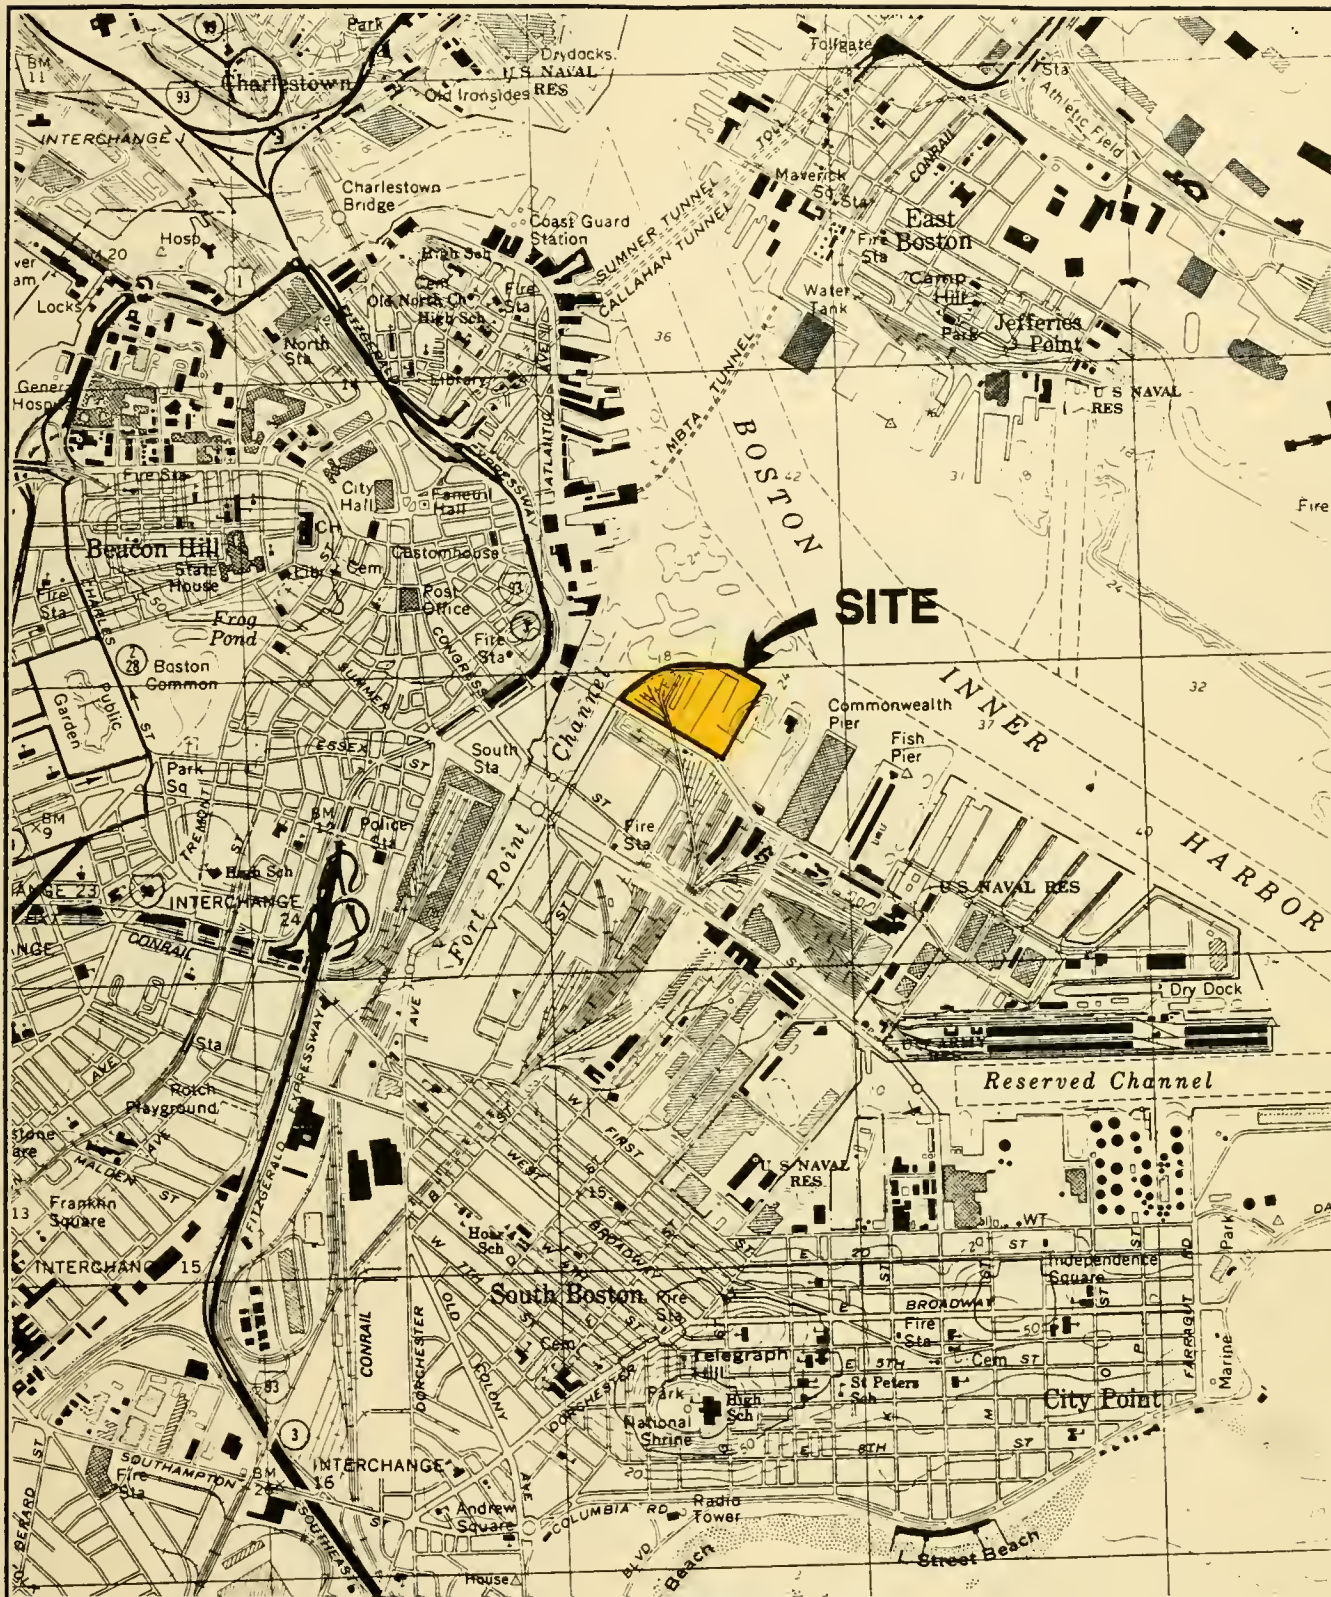
FIGURE 1

As shown in Figure 1, the site is located on the South Boston waterfront in an area which is zoned for waterfront industry (W-2) (1). The property under study is bounded by Boston Harbor, the Fort Point Channel, Northern Avenue, and property owned by Mr. Anthony Athanas of Anthony's Pier 4 Inc. The site is currently used for parking, and for docking facilities. A one-story sandwich shop and a warehouse are the only existing structures on site.

PROJECT LOCUS

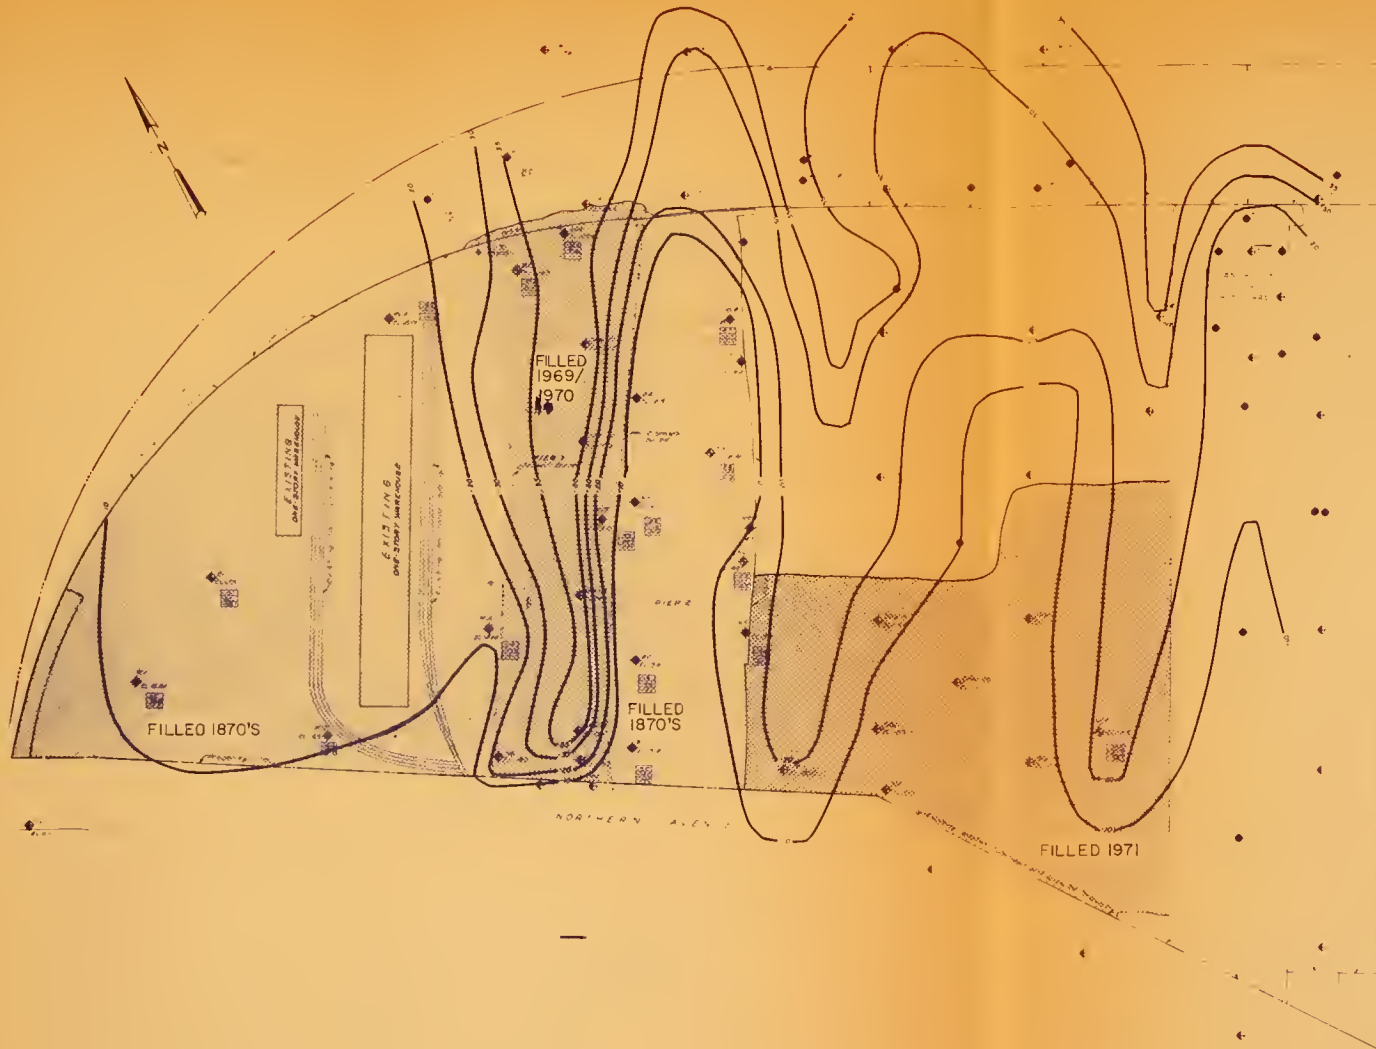
FIGURE 3

the bottom of these two units is shown on Figure 3. In general, the organic deposits consist of organic silt with shells and a variable clay content. The fill deposits were placed during a series of filling episodes which are discussed in detail below.

PLAN PREPARED FROM DATA
PRESENTED IN 1971 H&A REPORT

HALEY & ALDRICH, INC. CAMBRIDGE, MASSACHUSETTS CONSULTING GEOTECHNICAL ENGINEERS AND GEOLOGISTS
	PIERS 1-2-3 MASTER PLAN DEVELOPMENT BOSTON, MASSACHUSETTS
	TOP OF INORGANIC SOILS CONTOUR PLAN
	SCALE: 1" = 200' OCTOBER 1984

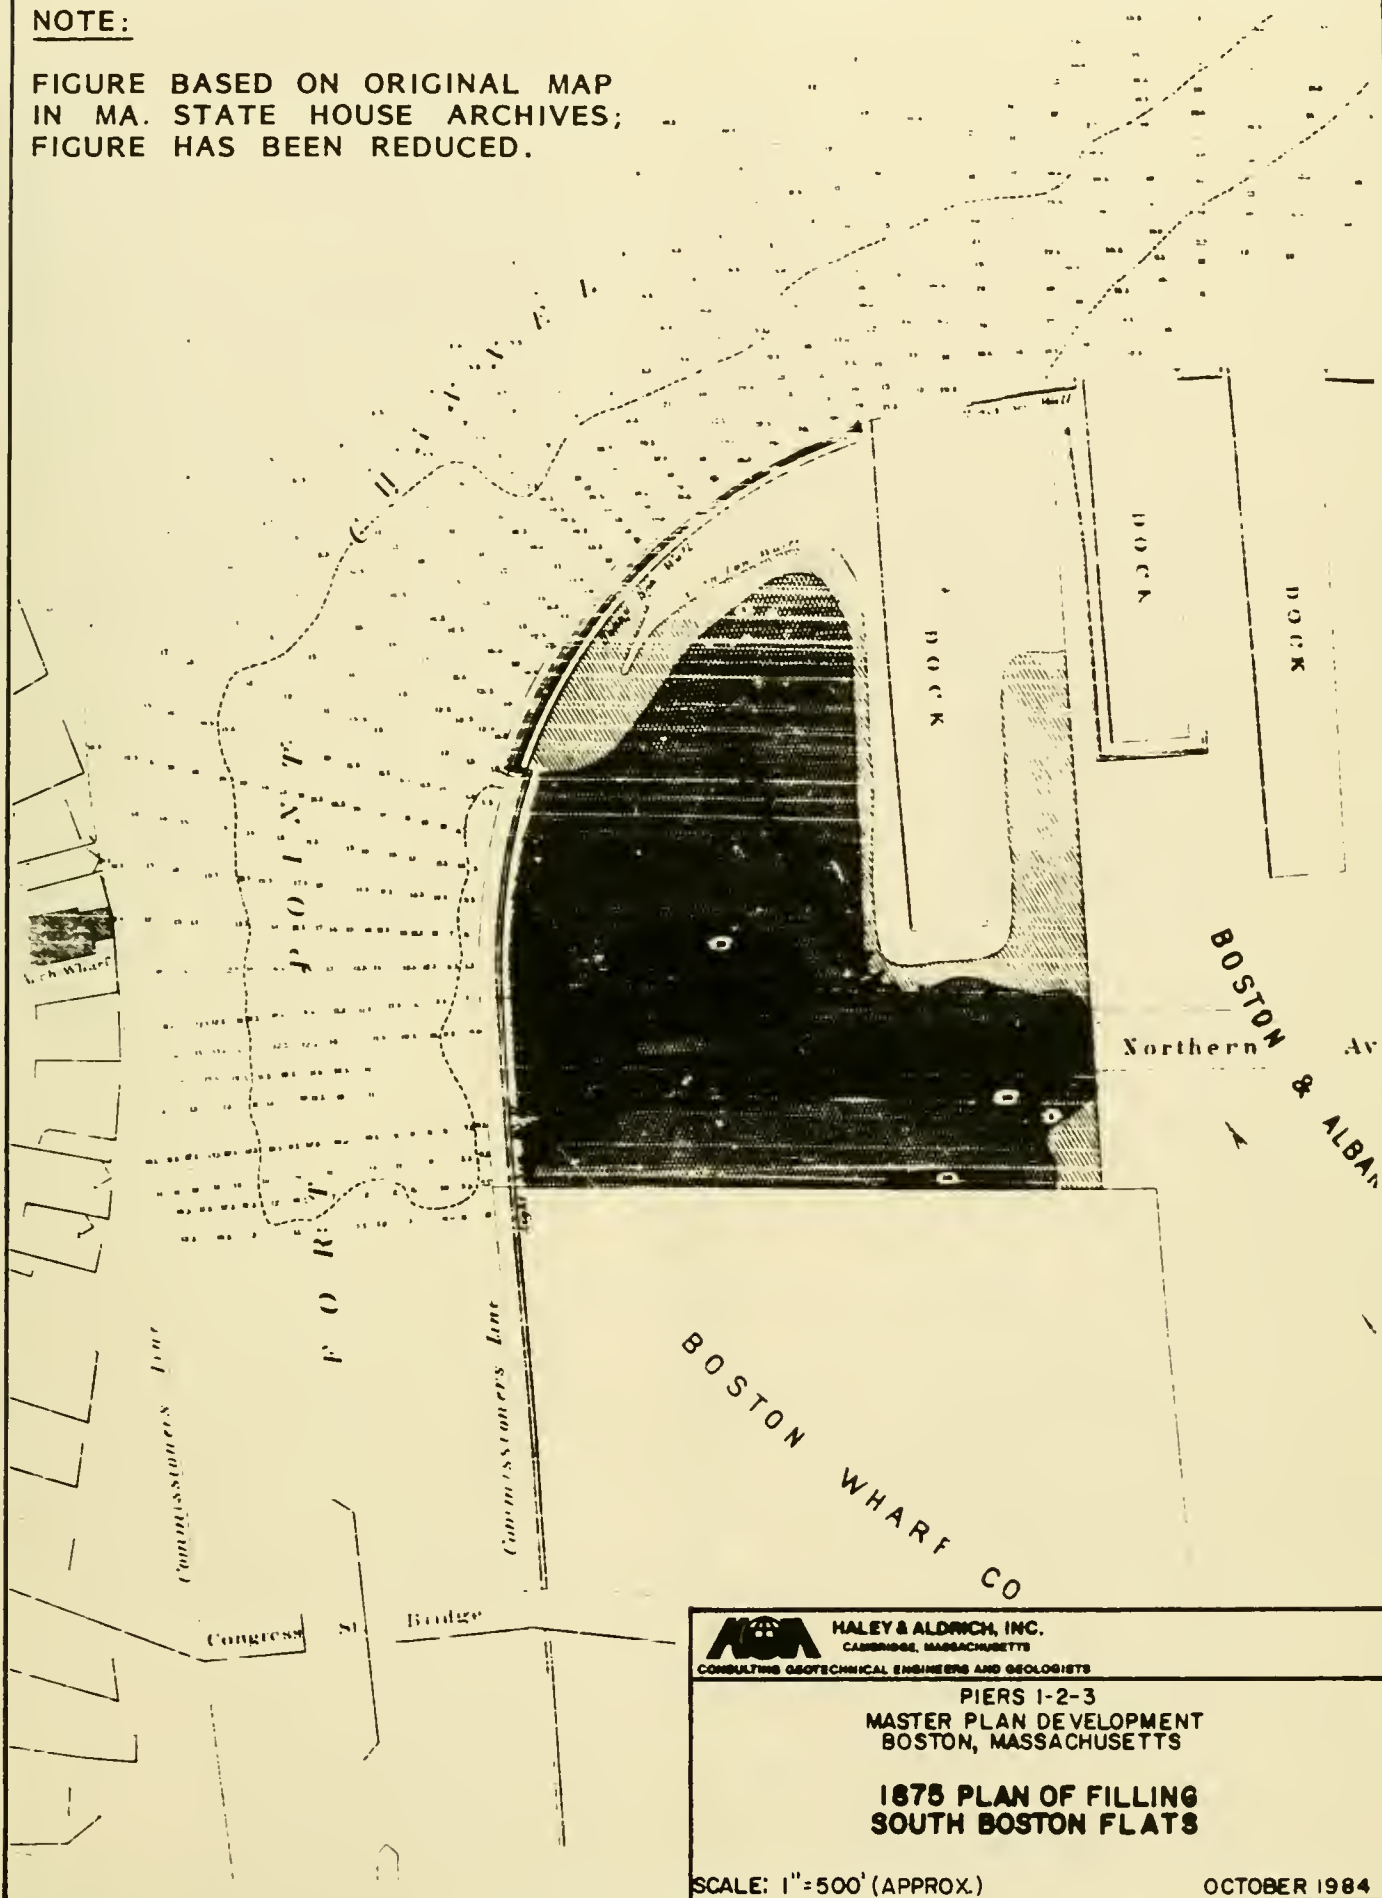
FIGURE 4

FIGURE BASED ON ORIGINAL MAP
IN MA. STATE HOUSE ARCHIVES;
FIGURE HAS BEEN REDUCED.

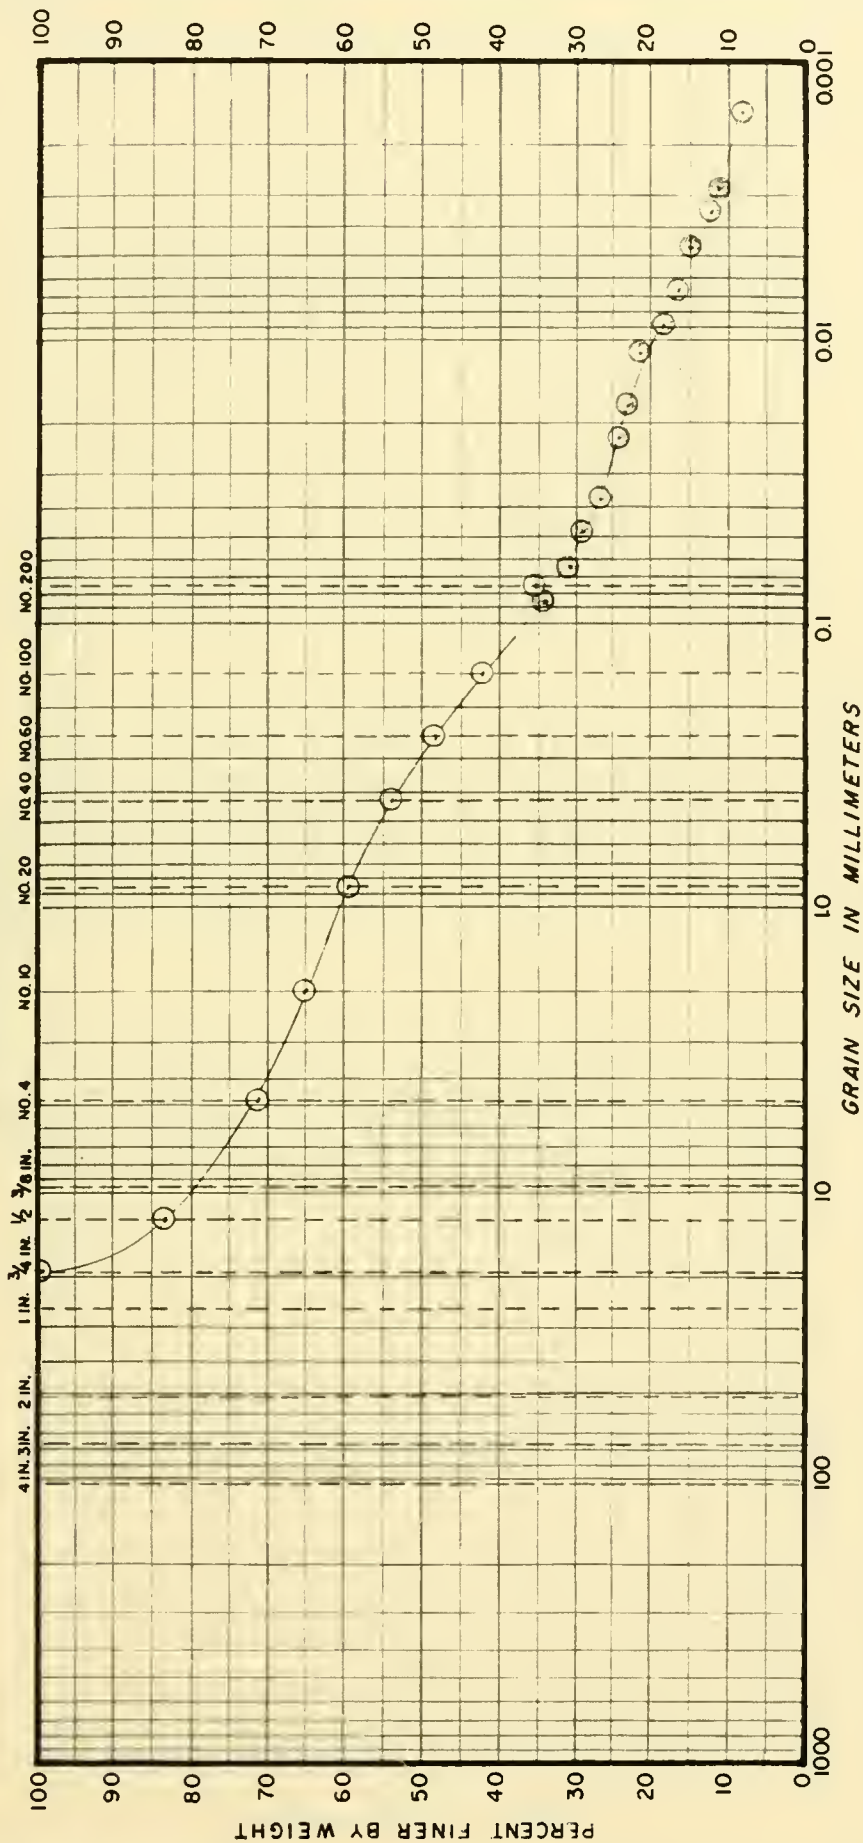
GRAIN SIZE DISTRIBUTION

Grain size analysis classification of four samples from test pits 84-6A, 84-11, 84-12 and 84-13 were performed in the Haley & Aldrich, Inc. laboratory. The results of these tests are included in Appendix C.
